# Methamphetamine FC Screening Assessment Report

Address inspected: 12 Vida PI, Howick, Auckland

Date of Inspection: 15/09/2020 Time: 10:00am

## **ASBESTOS SAMPLE REPORT & REGISTER**

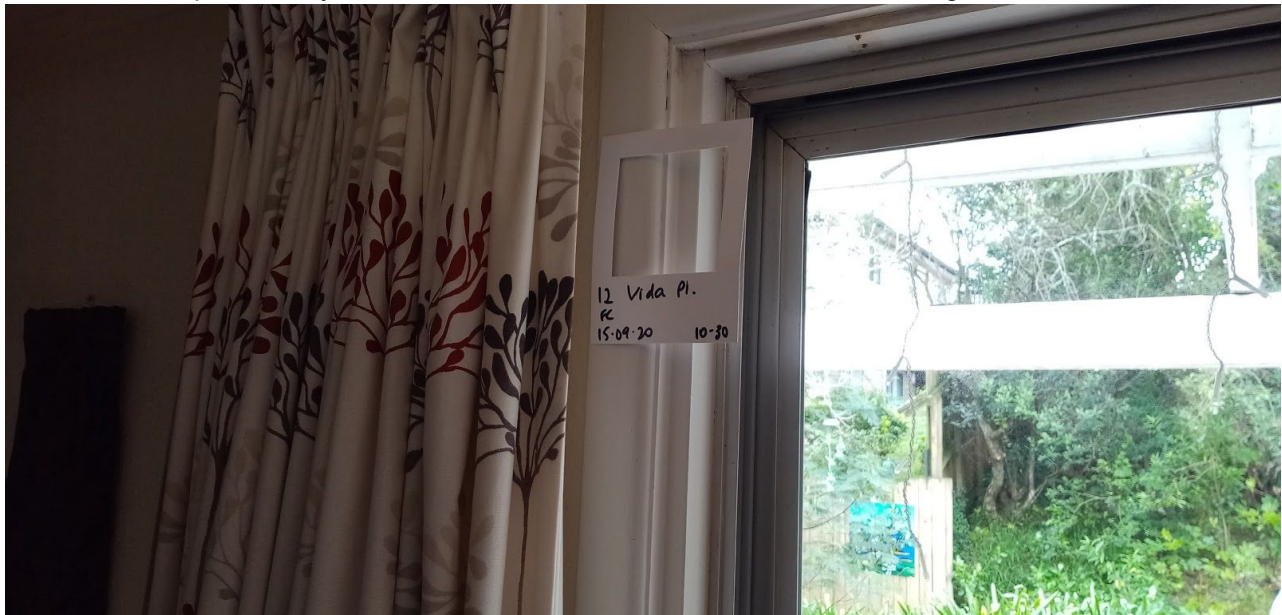
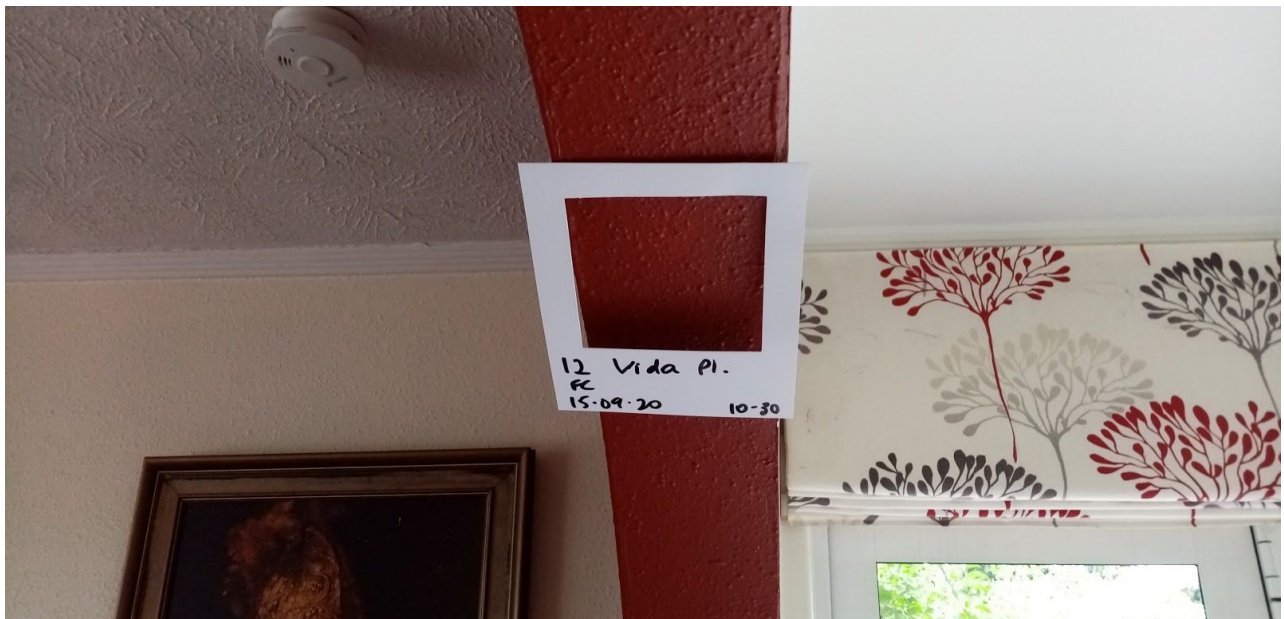
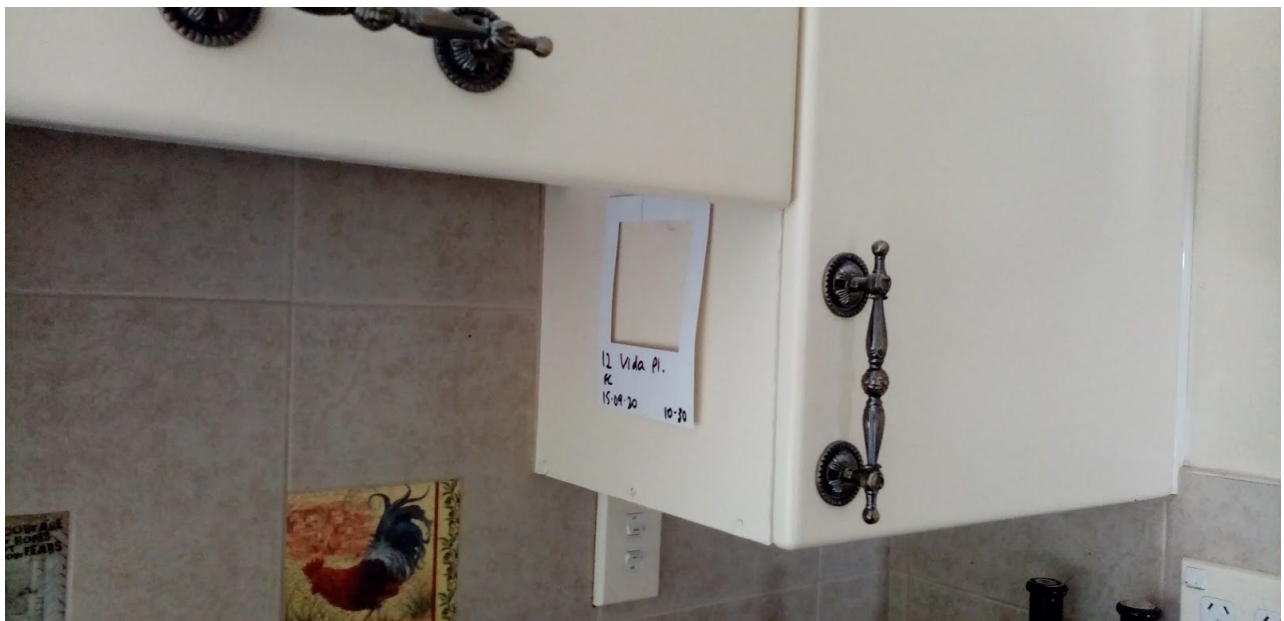
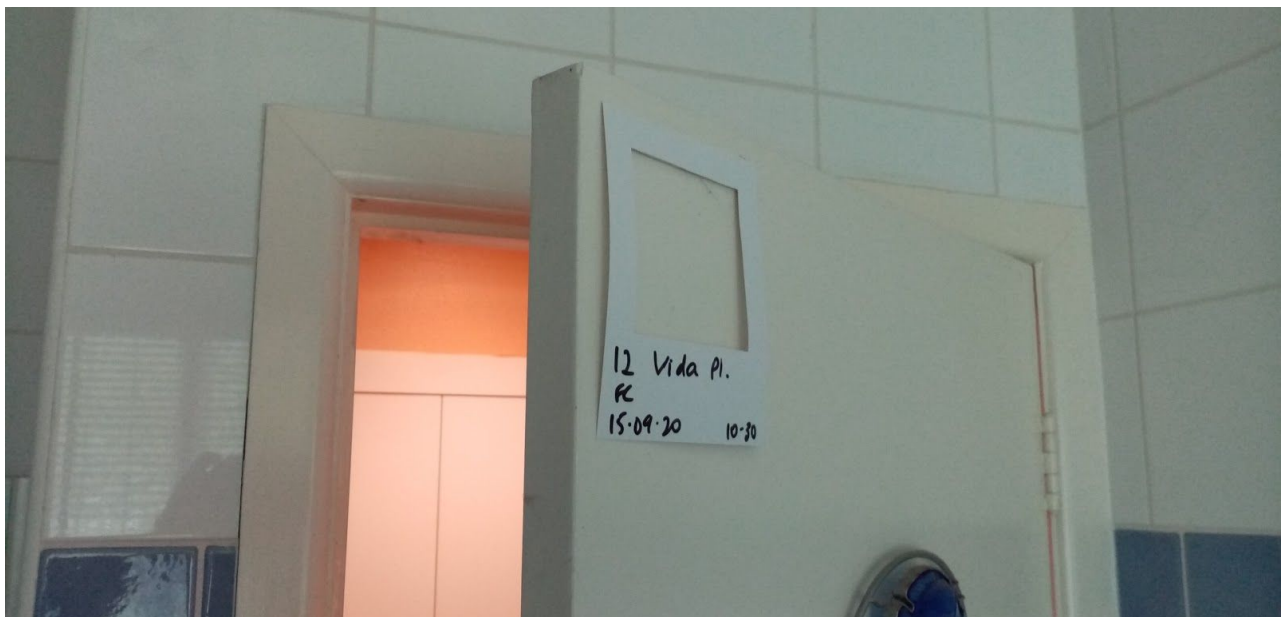
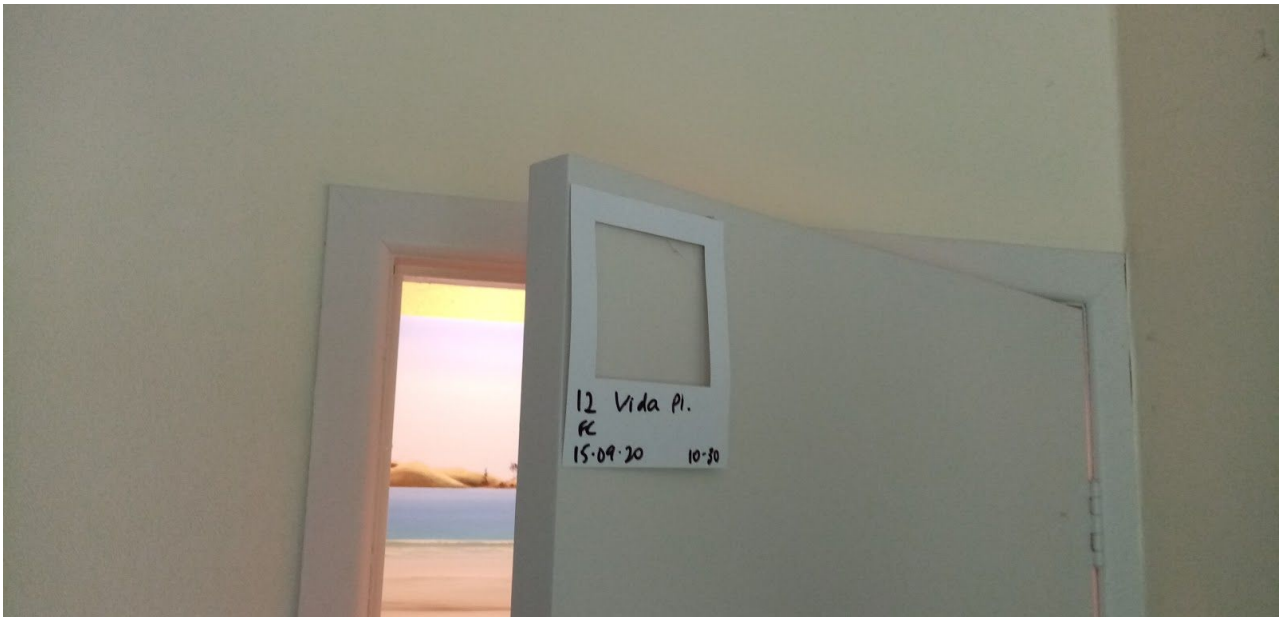
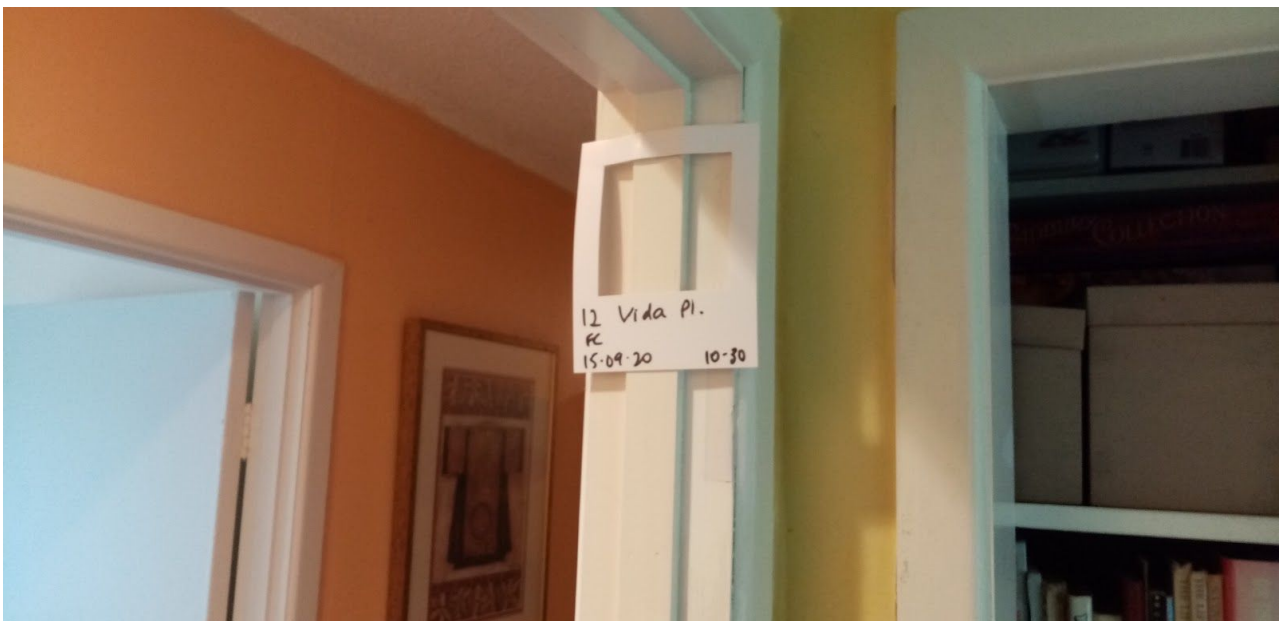
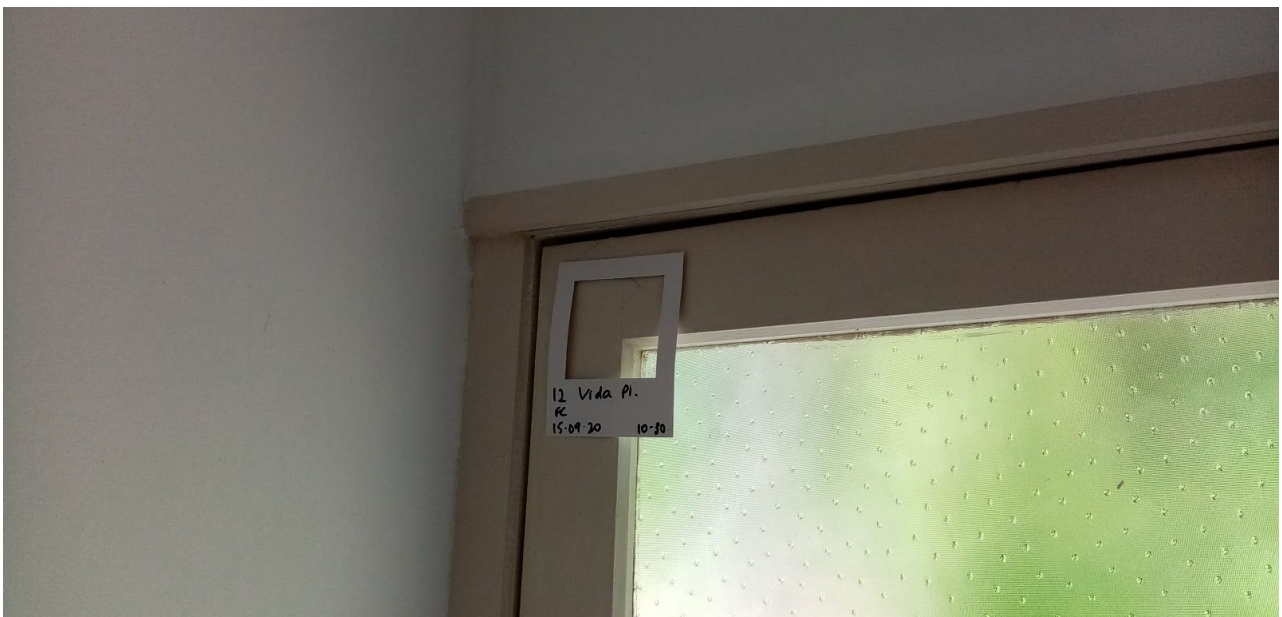
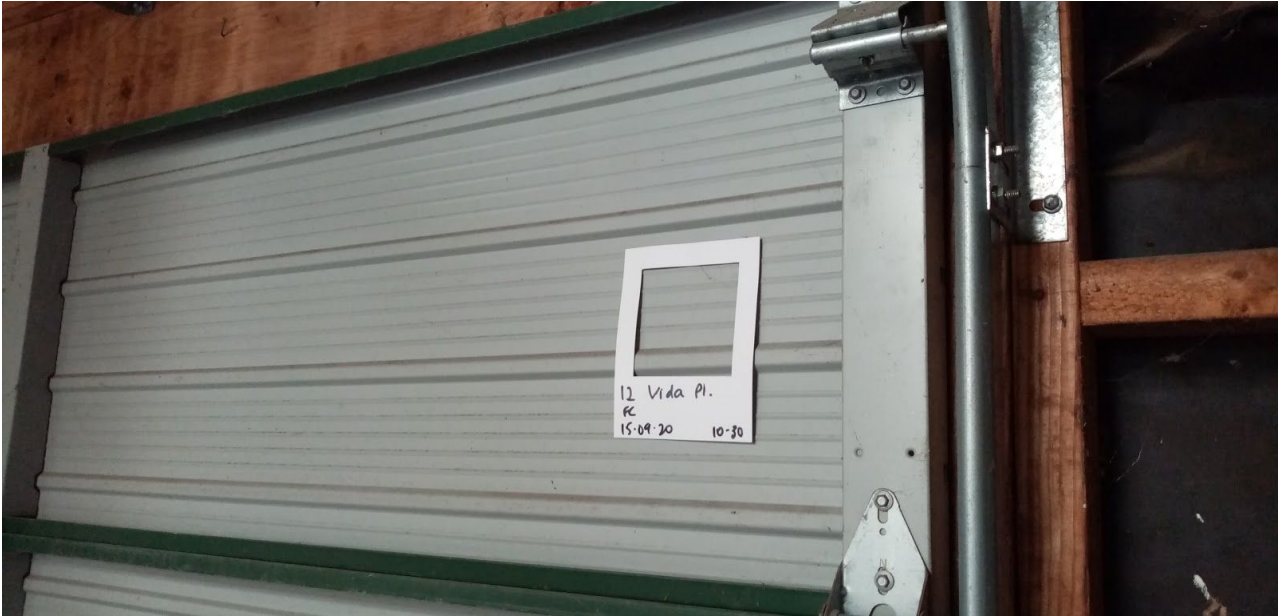
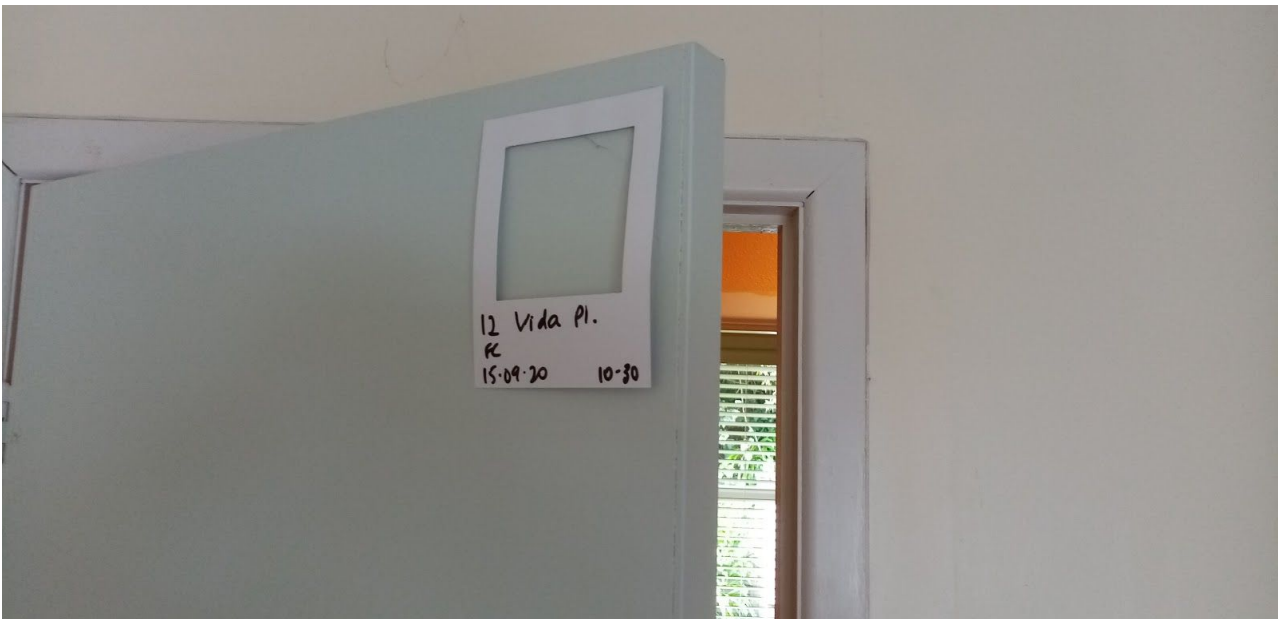
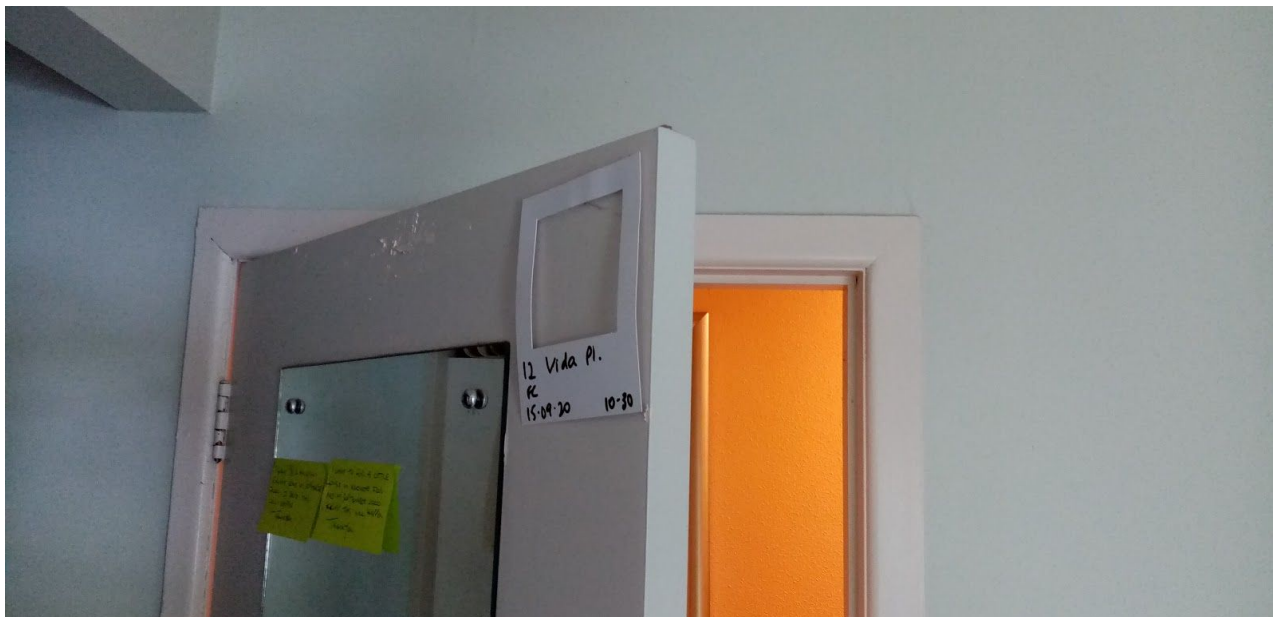
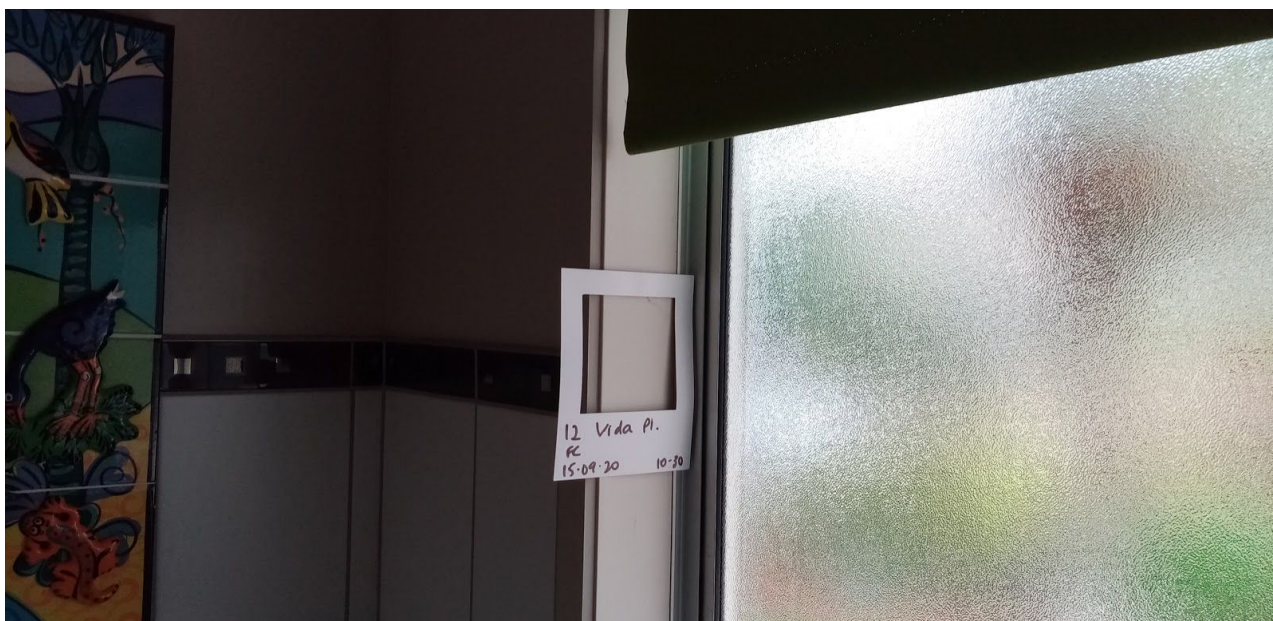
**Pictures are for reference if further testing or other evaluation needed.**

Photos and samples usually taken in a clockwise direction around house, starting in kitchen.

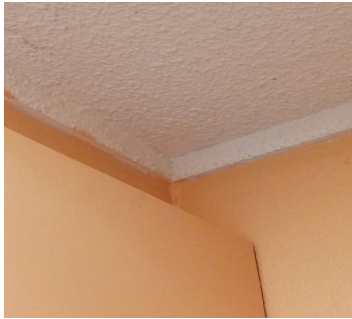
<b>Notes</b> This house		
<b>AREA 1.</b>  <b>SAMPLED</b>	<b>Material:</b> <ul style="list-style-type: none"> <li>• CEILING PLASTER, HALL.</li> <li>• 2 locations of same material, same room sampled.</li> </ul>

More photos end of doc.
<b>SAMPLE RESULT</b>	<b>ASBESTOS (ACM) DETECTED:</b> See attached lab results	Type: <b>Chrysotile (White Asbestos)</b> Hazard level: <b>Low - stable, not friable.</b>
<b>REGISTER</b>	Report emailed to client.	
<b>RECOMMEN DATIONS</b>	<b>Notify anyone before doing work in this area.</b> <b>Only remove using a registered / certified asbestos remover.</b> <b>Dispose of as hazardous waste.</b>

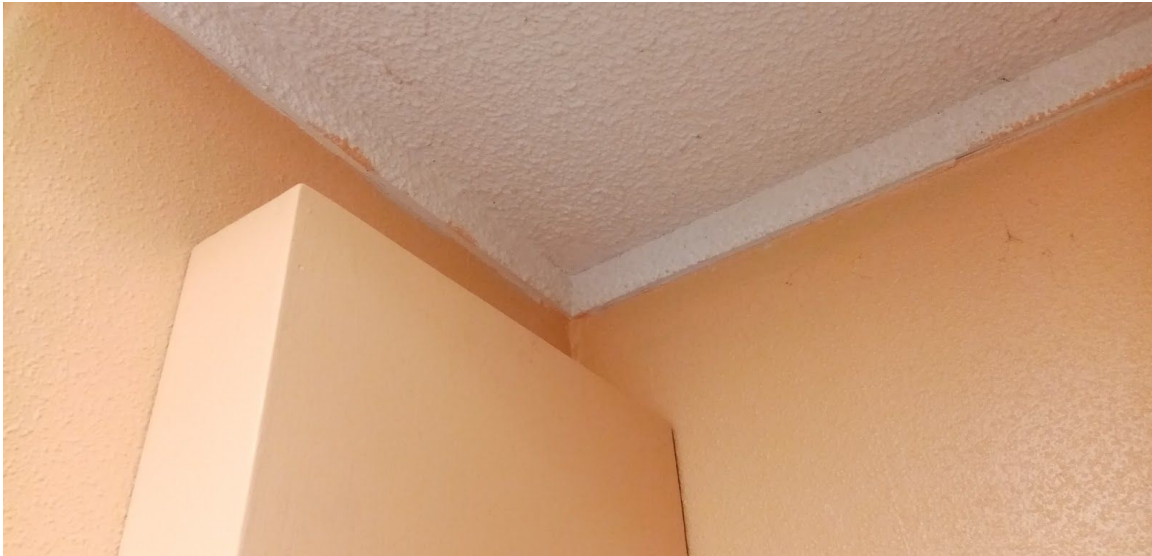
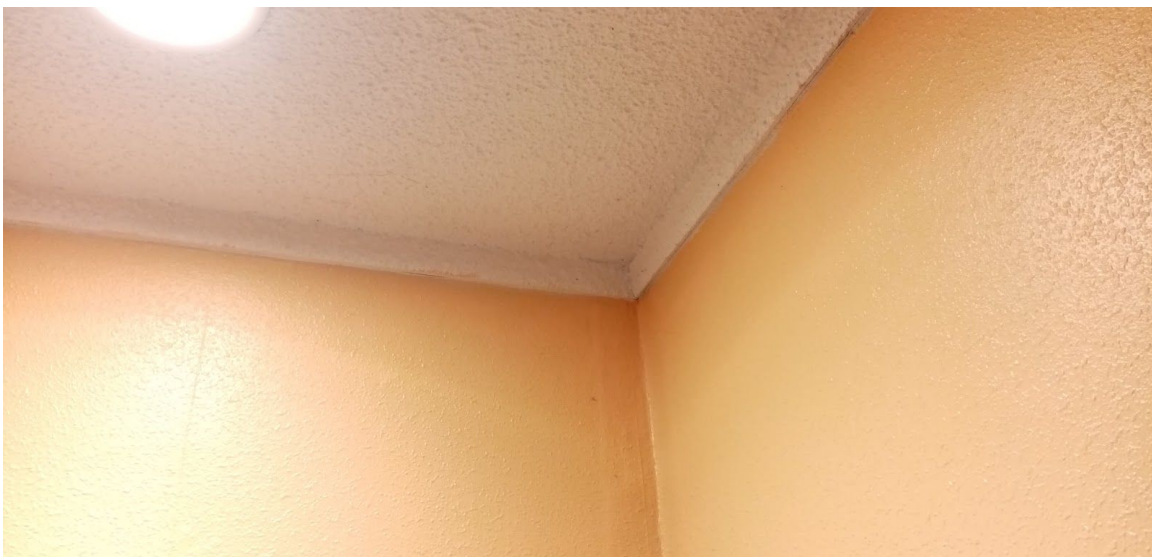
One area of this material only - hallway ceiling plaster.approx 10m2.
